## CITY OF OCONTO FALLS NOTICE OF PUBLIC HEARING

RE: Public Hearing on the Determination of Slum & Blight

## Property Photos to accompany Slum & Blight Letter

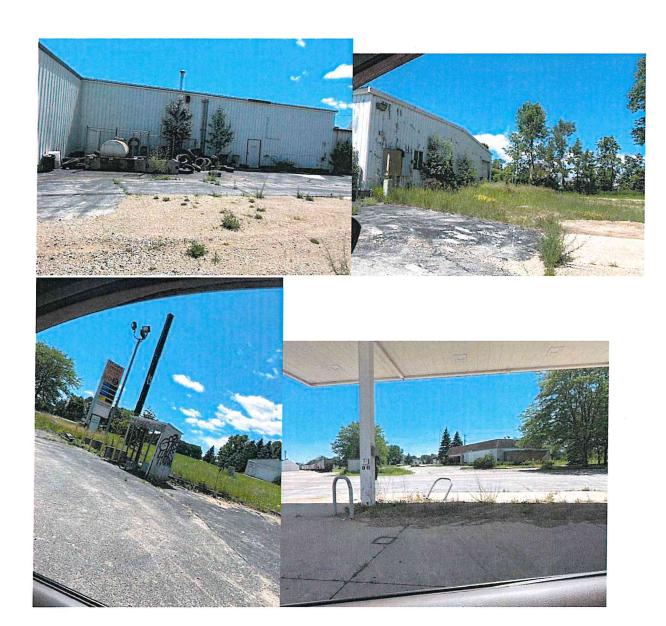
# 710 County B-Former Mobil Station

Based on the former Mobil gas station property, 710 County Road B, Administratively Dissolved-the property owners Sooch Inc was administratively dissolved in 2009, the property has been abandoned since 2017.

Property Taxes on 710 County Road B have not been paid since 2017, Bank is in foreclosure, liens from the State of Wisconsin.

710 County Road B property has piles of tires, oil tank behind retail store, peeling paint, former repair shop may have petroleum contamination.

- A. Wis. Stats. 66.133 Blighted Area and Blighted Property Determination Recommendation
  - (1) Blighted Area–710 County B and 782 N Main Street properties should be determined to be blighted based on the condition of physical deterioration of buildings on both of the properties.
